Order-No.: DD+DIS121.00E

Field Service Bulletin Nr. 10 for ADC Solo Type: 5155

IP Jam in Scan Unit

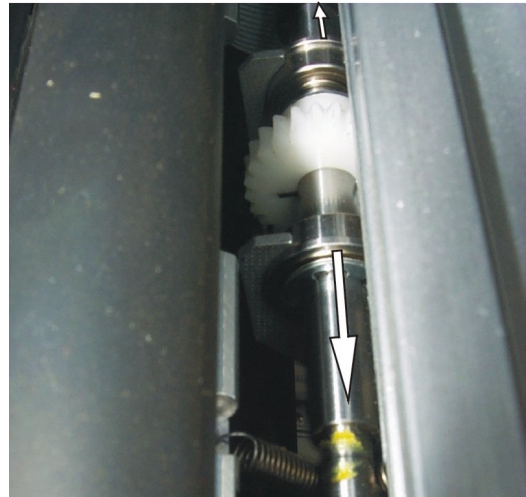
Figure 2

Technicians have reported that at some scan units of the ADC Solo wave spring washers (Figure 1) are missing. If wave spring washers are missing, deep groove ball bearings gradually may move away from their intended position (Figure 2 (arrows)).

1. Remove right side panel.
2. Unplug bus connection and power connection of the IP-transport unit.
3. Open four quick-action closures and remove the IP-transport unit. Put it in a safe place.
4. Check with scan unit, whether wave spring washers are in place or not (Figure 2).
5. If not, cover the VME Rack with a piece of cloth or a large piece of paper.

7. Move the deep groove ball bearings on the drive shaft as close as possible to the motor (Figure 2, opposite direction of arrows). This can be done with the fingers.
8. Slip the wave spring washers in the groove next to the deep groove ball bearings (follow as indicated by (A)).
9. Attach the metal shield to the motor again.
10. Set the IP-transport unit back to its position.
11. Lock the quick-action closures, insert the plugs in the sockets and close the side panel.

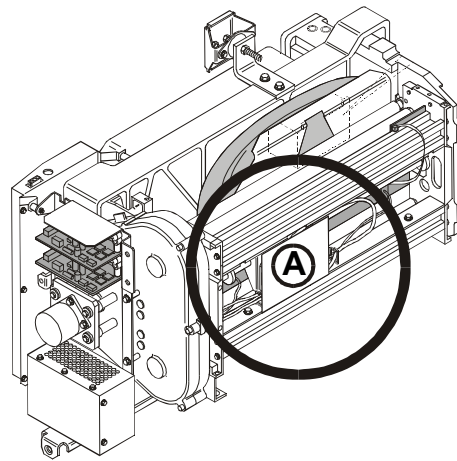
Figure 3

6. Loosen the metal shield from the motor (A) to get access to the drive shaft.
